**FEDERAL WETLAND
DELINEATION REPORT
FOR**

**THE WINDHAM MOUNTAIN SPORTING CLUB
TOWN OF WINDHAM
GREENE COUNTY, NEW YORK**

**PREPARED FOR
TUCK EASTSIDE PARTNERS, L.P.
34 SALISBURY ROAD
DARIEN, CT 06820**

**PREPARED BY
THE LA GROUP, P.C.
40 LONG ALLEY
SARATOGA SPRINGS, NEW YORK 12866**

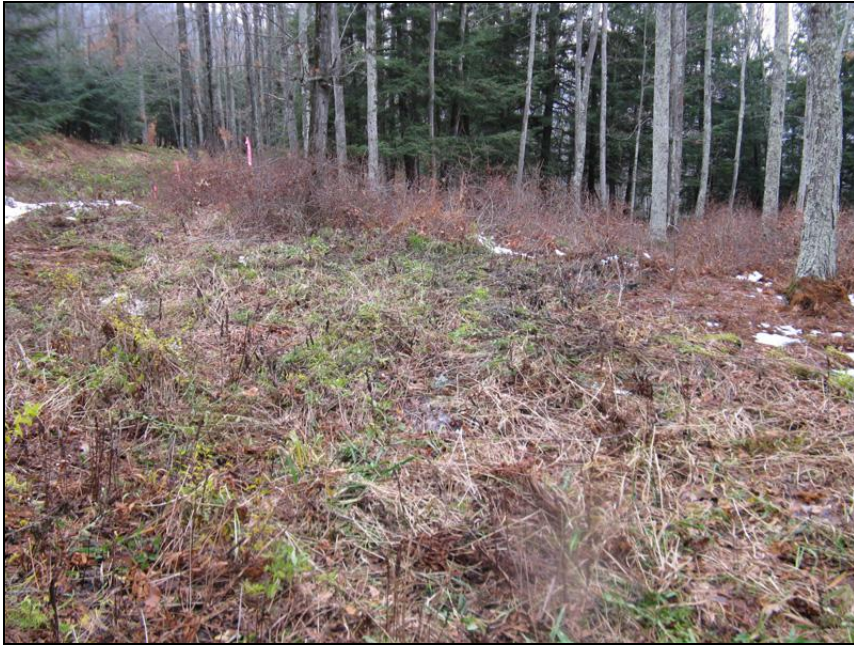
Photo 1. Wetland near flag CK-12.

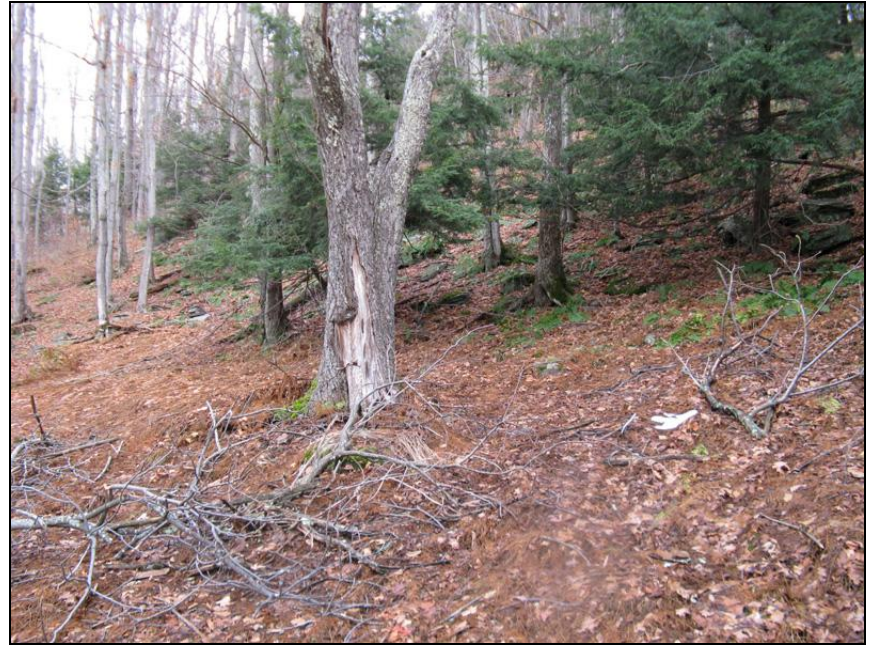
Photo 2. Upland near flag CK-12.

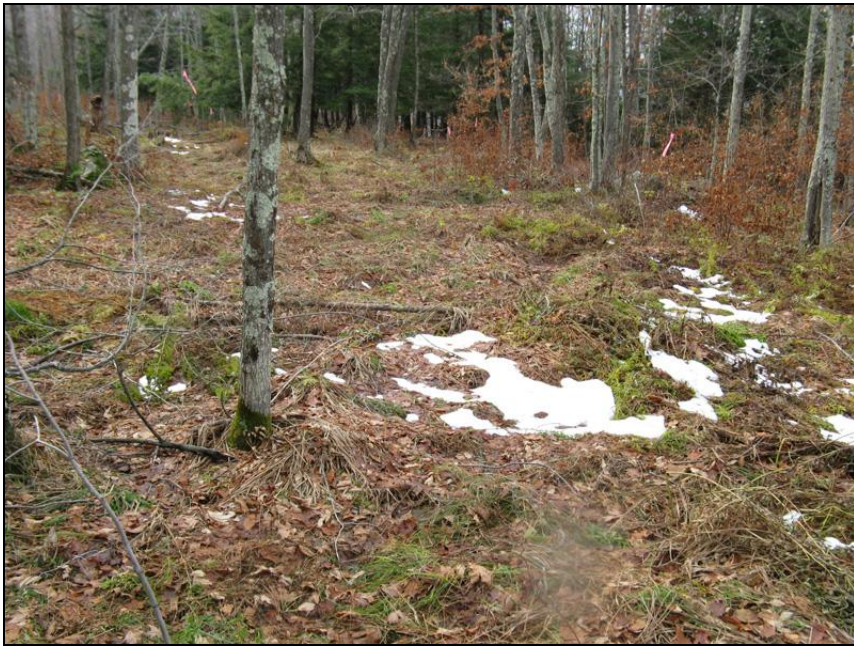
Photo 3. Wetland near flag CM-47.

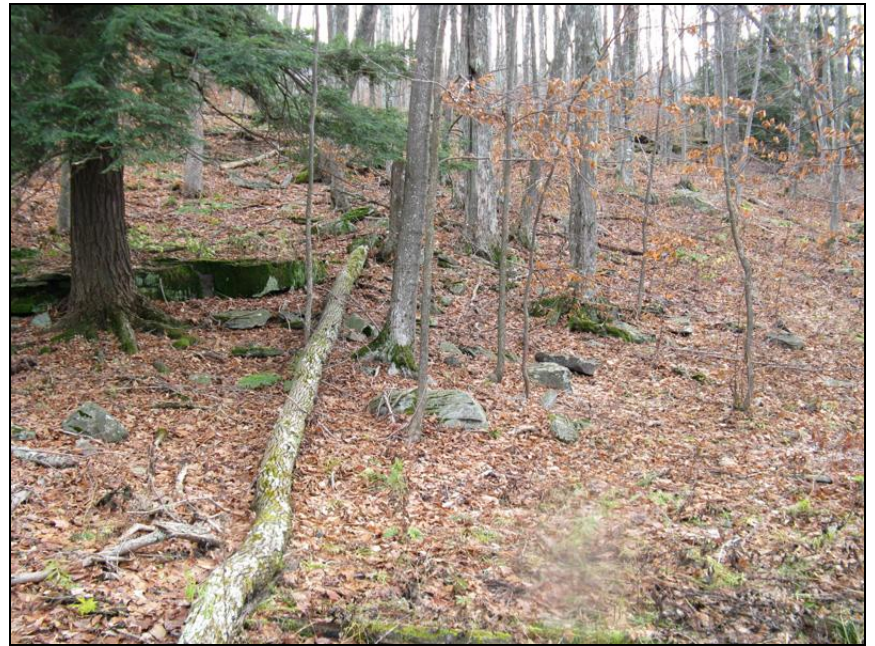
Photo 4. Upland near flag CM-47.

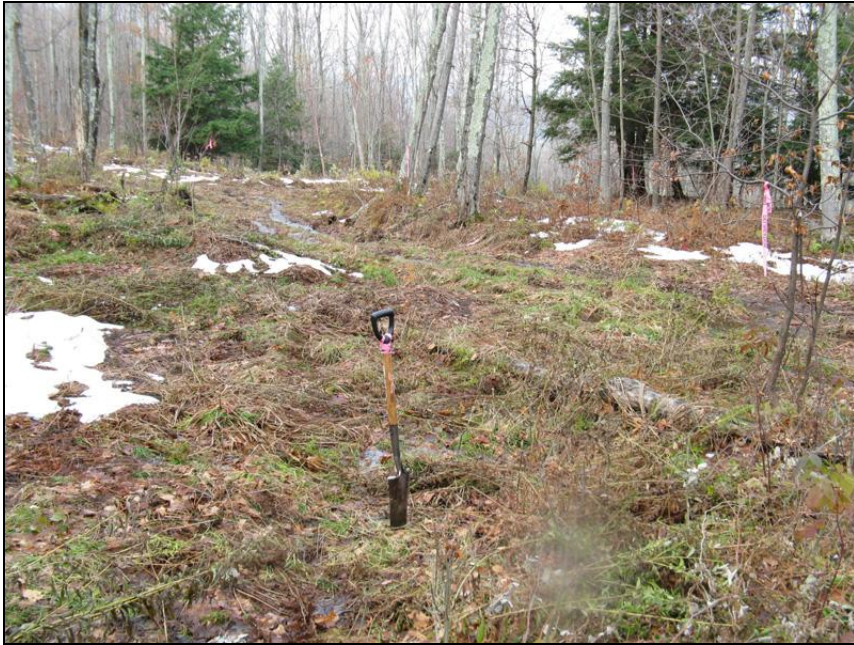
Photo 5. Wetland at CQ-113.

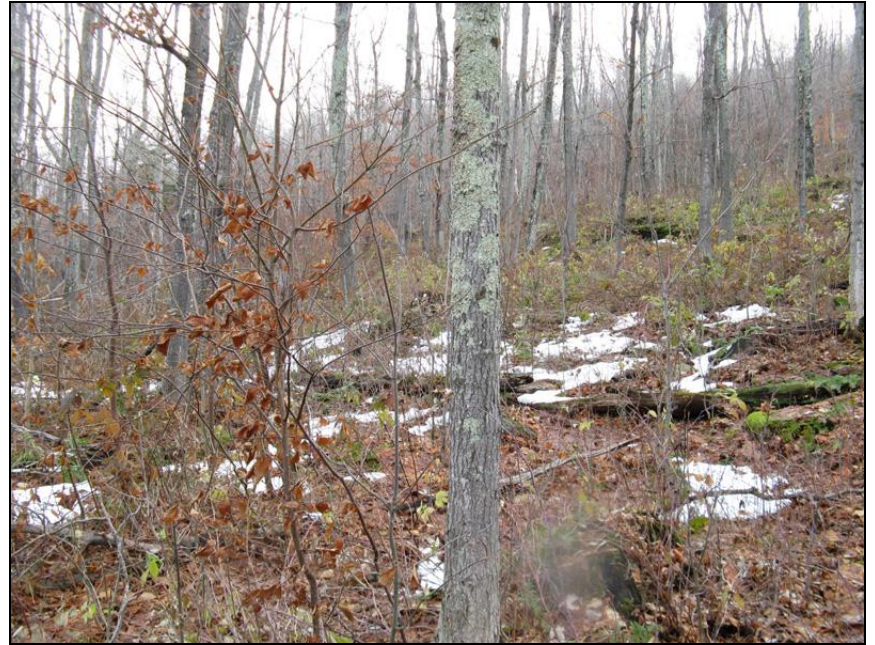
Photo 6. Upland near flag CQ-113.

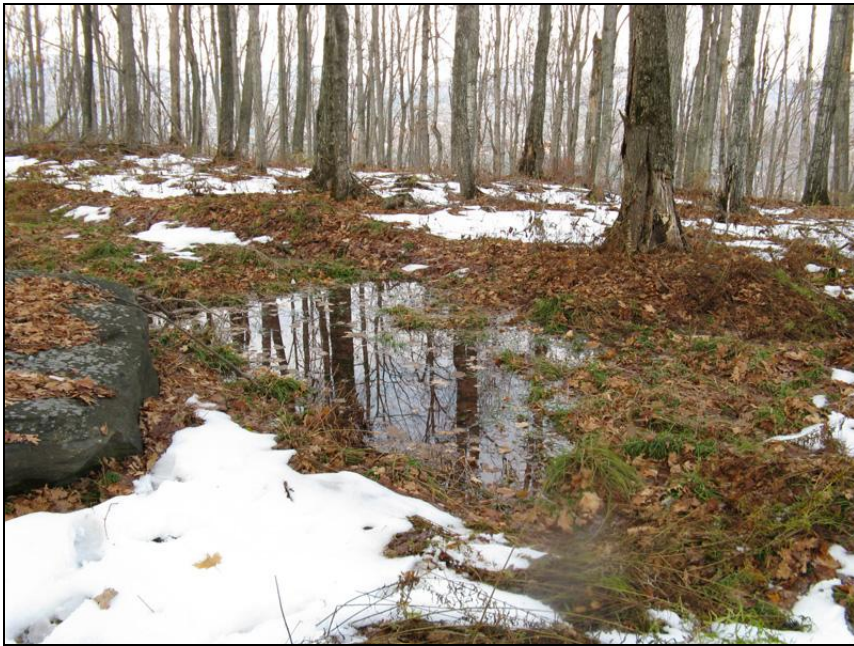
Photo 7. Wetland at CS-7-W.

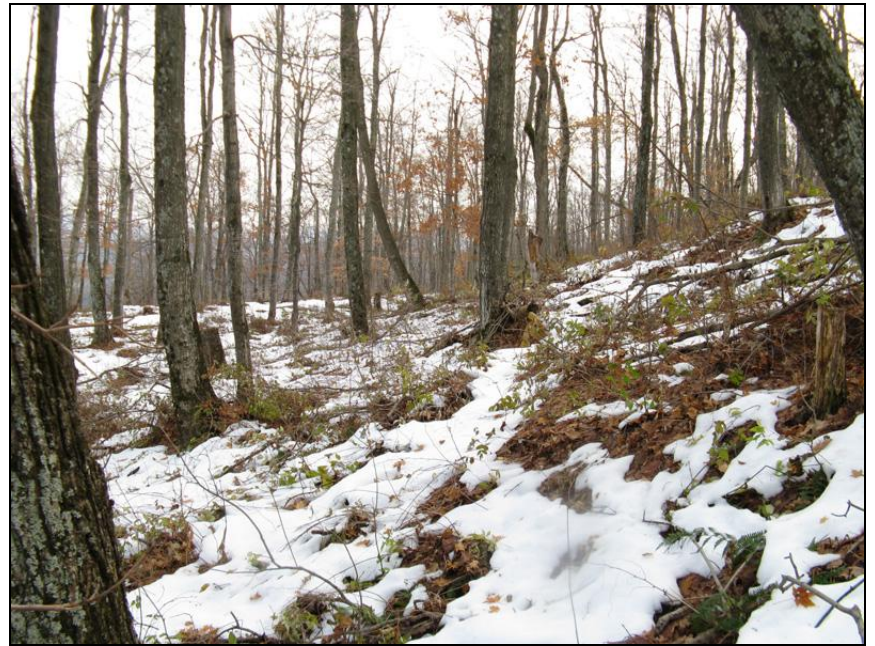
Photo 8. Upland near CS-7.

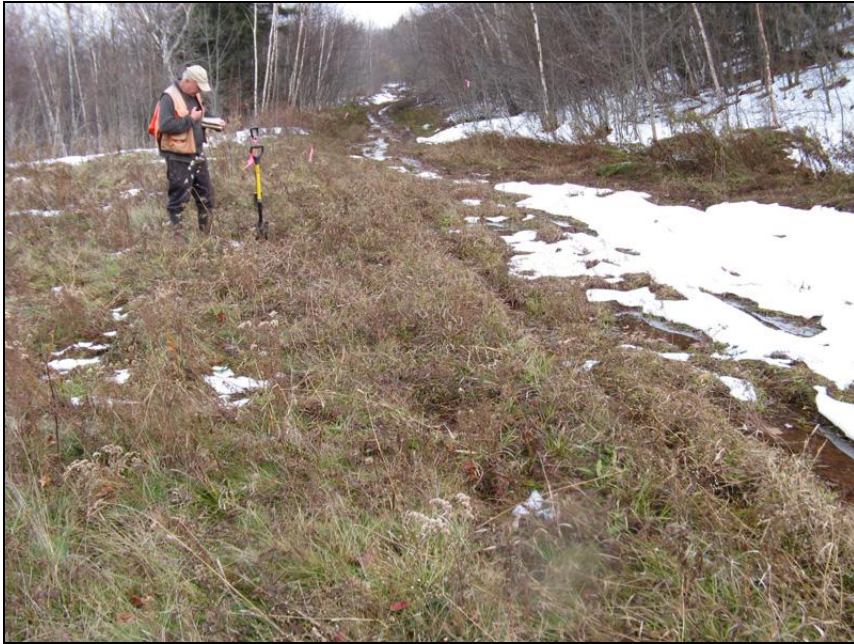
Photo 9. Wetland at flag CV-1.

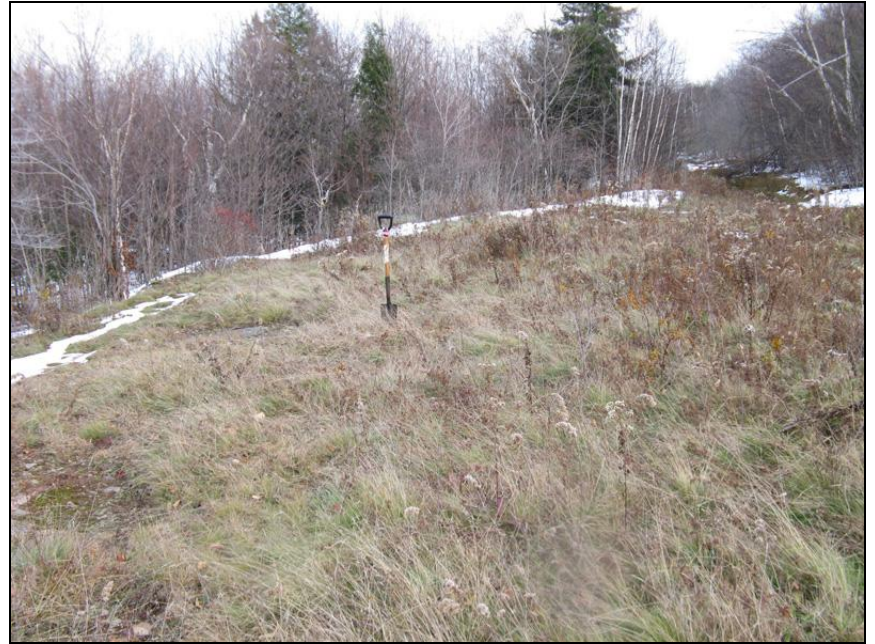
Photo 10. Upland at CV-1.

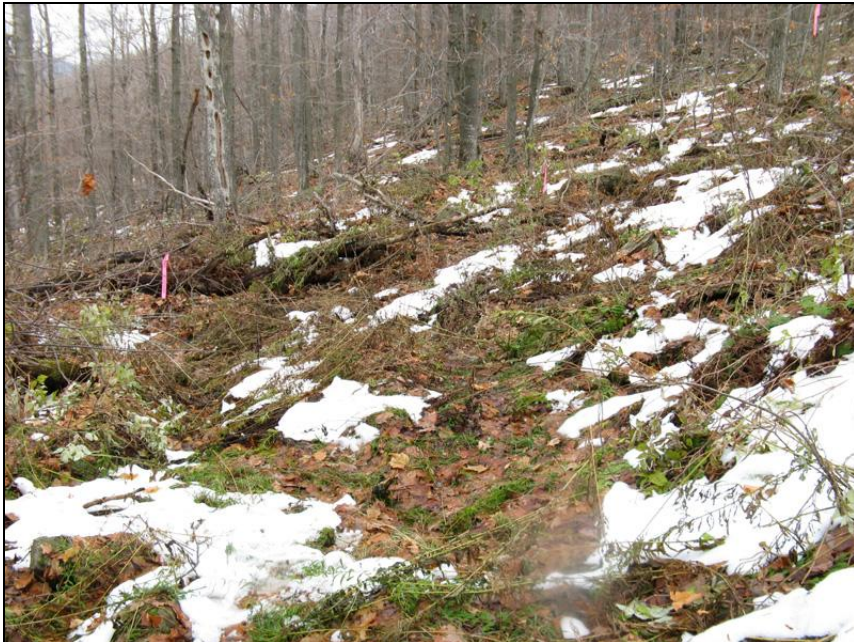
Photo 11. Wetland at DC-15.

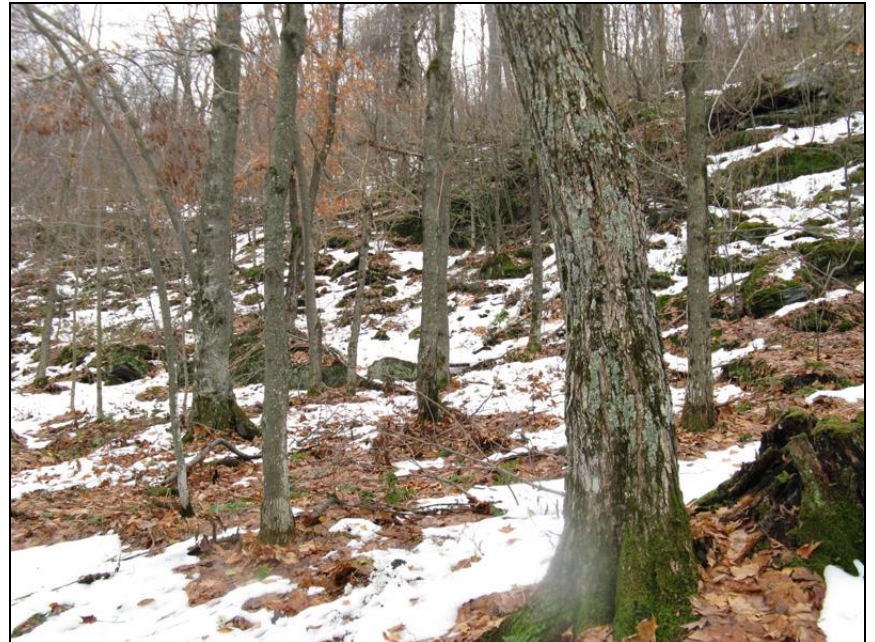
Photo 12. The upland near DC-2.

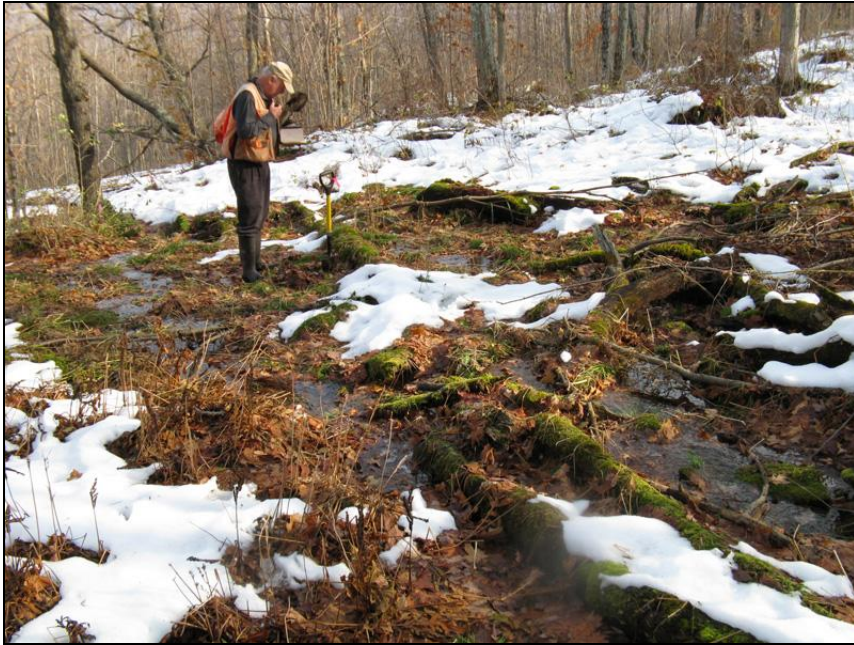
Photo 13. Wetland at GE-10.

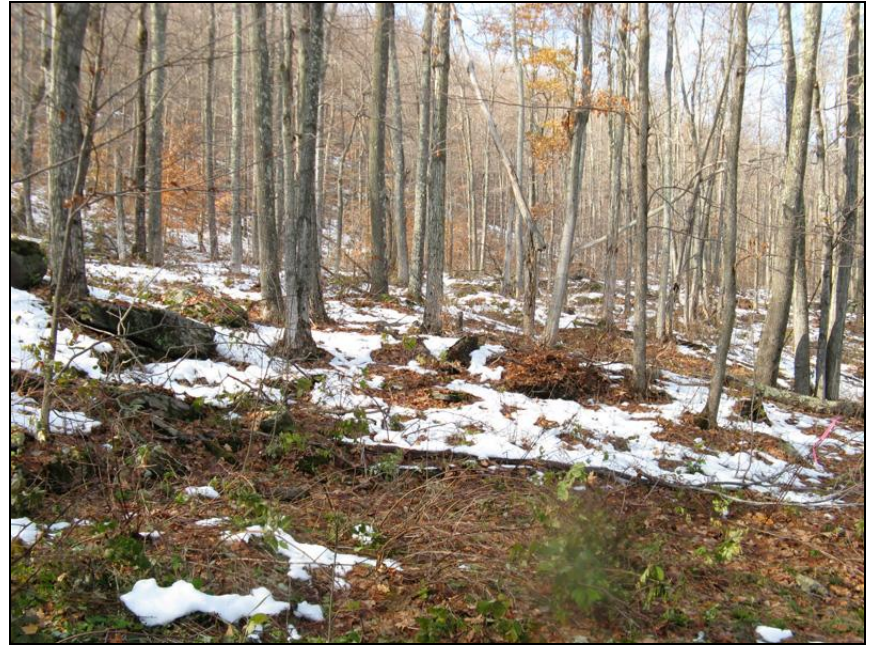
Photo 14. Upland near GE-10.

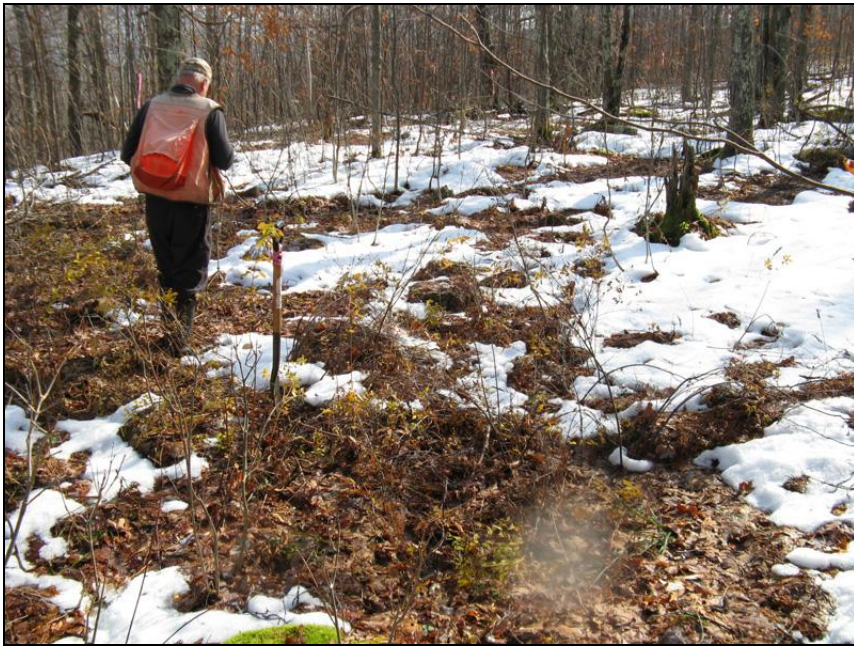
Photo 15. Wetland near flag GX-3.

Photo 15. Line GX bounds a wetland in a seepy are on a moderately gentle slope. Red maple and green ash are the dominants in the tree and sapling layers. Dominant trees are red raspberry and narrow-leaf meadow-sweet. Sensitive fern, lady-fern, and fringed sedge are the dominant herbs. Photographed Nov. 4, 2008.

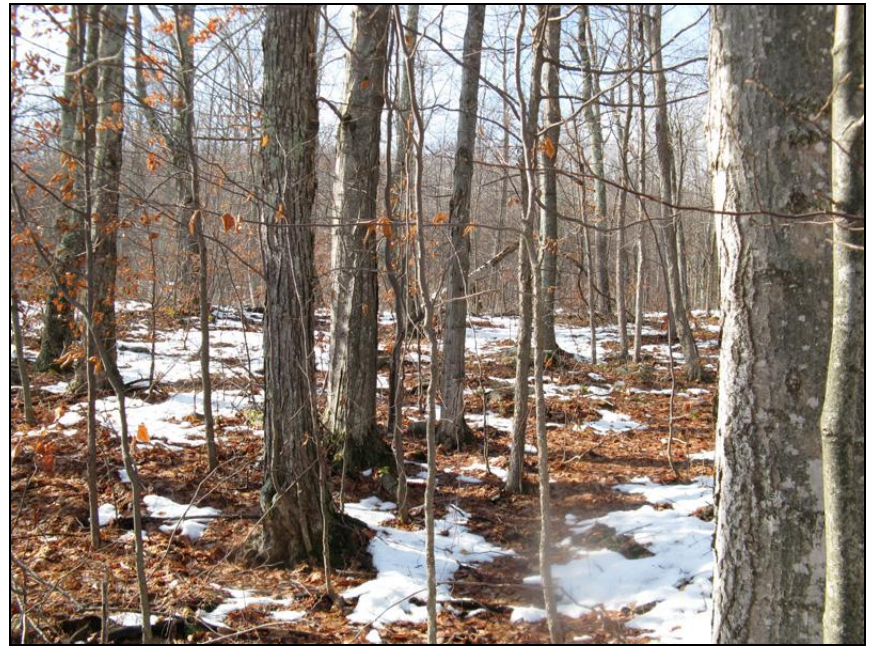
Photo 16. The upland near flag GX-3.

Photo 16. The upland near flag GX-3 is a hardwood forest of sugar maple, red maple, northern red oak, and hop-hornbeam. There are few shrubs to speak of. The dominants in the herb layer are common speedwell, red raspberry, and Pennsylvania sedge. Photographed Nov. 4, 2008.
